SAND98-1016

Damage Tolerance Assessment of Bonded Composite Doubler Repairs for Commercial Aircraft Applications

Dennis Roach

Sandia National Laboratories

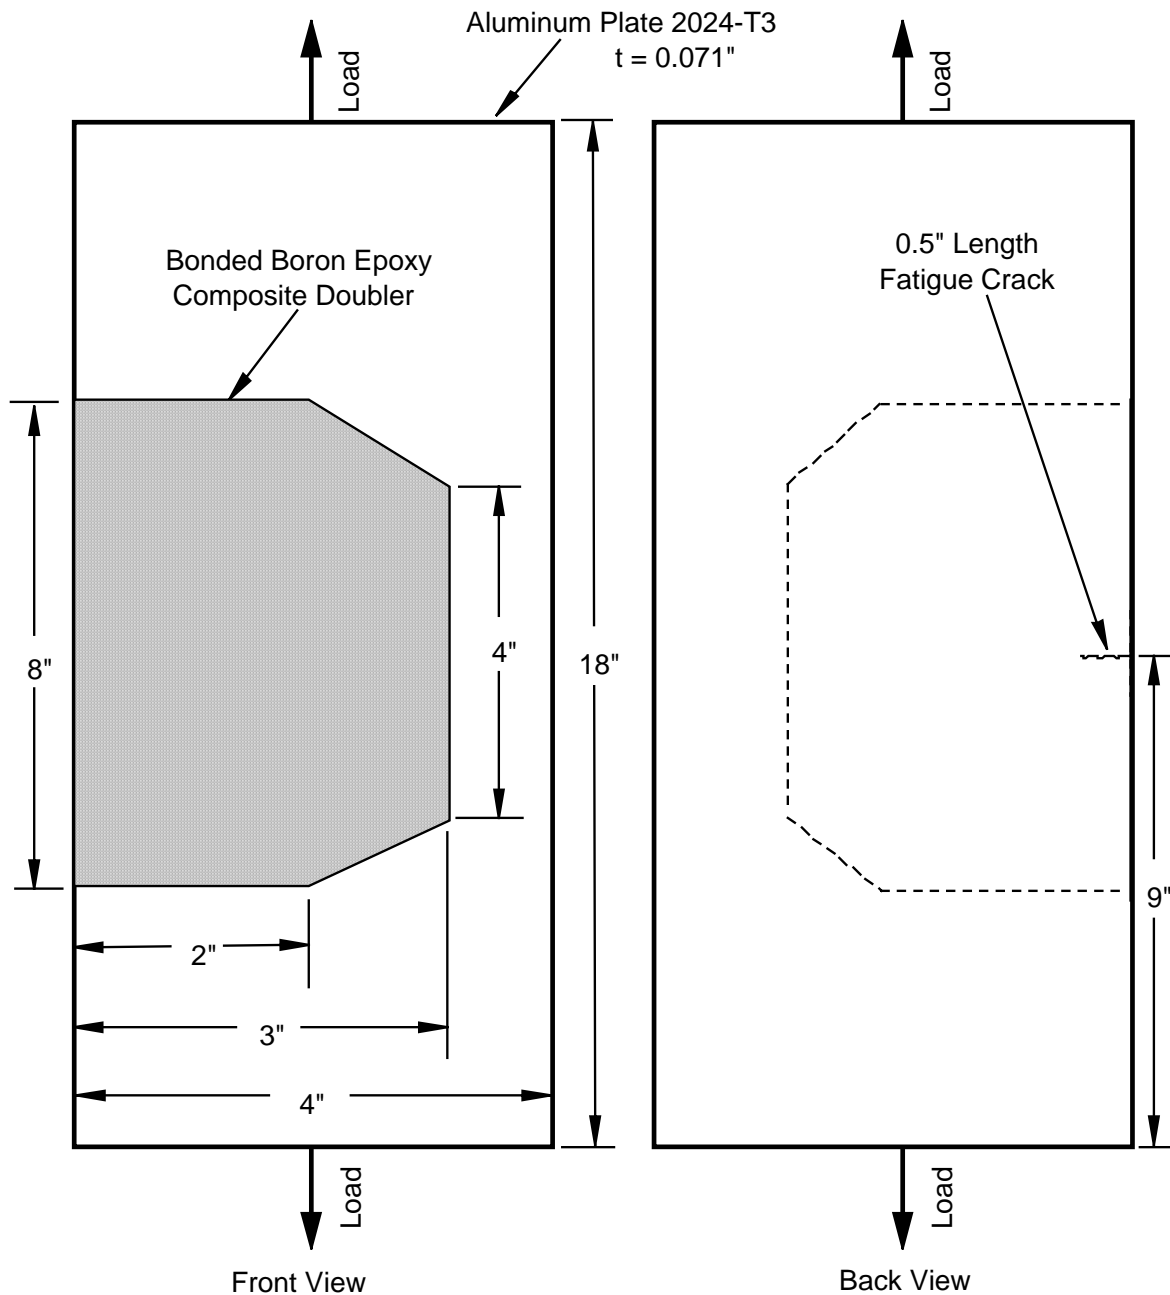
Figure 7: Composite Tension Test Coupon - Configuration BE-1

1. BE-1: Unabated 0.5" fatigue crack at the edge of the aluminum plate; no engineered flaws in composite doubler (Figure 7).
2. BE-2: Stop-drilled, 0.5" sawcut edge crack in the aluminum plate with collocated 0.75" dia. disbond between composite doubler and aluminum; 0.75" dia. disbonds along doubler edge (Figure 8).

1. 13 Ply Boron/Epoxy doubler
2. $[0, +45, -45, 90]_3$ lay-up (fiber orientation to the load) plus a 0° cover ply on top; longest ply on bottom
3. 30:1 taper ratio drop off
4. Stiffness Ratio, $(Et)_{BE} = 1.2 (Et)_{Al}$
5. Fatigue crack in skin but no engineered flaws in doubler

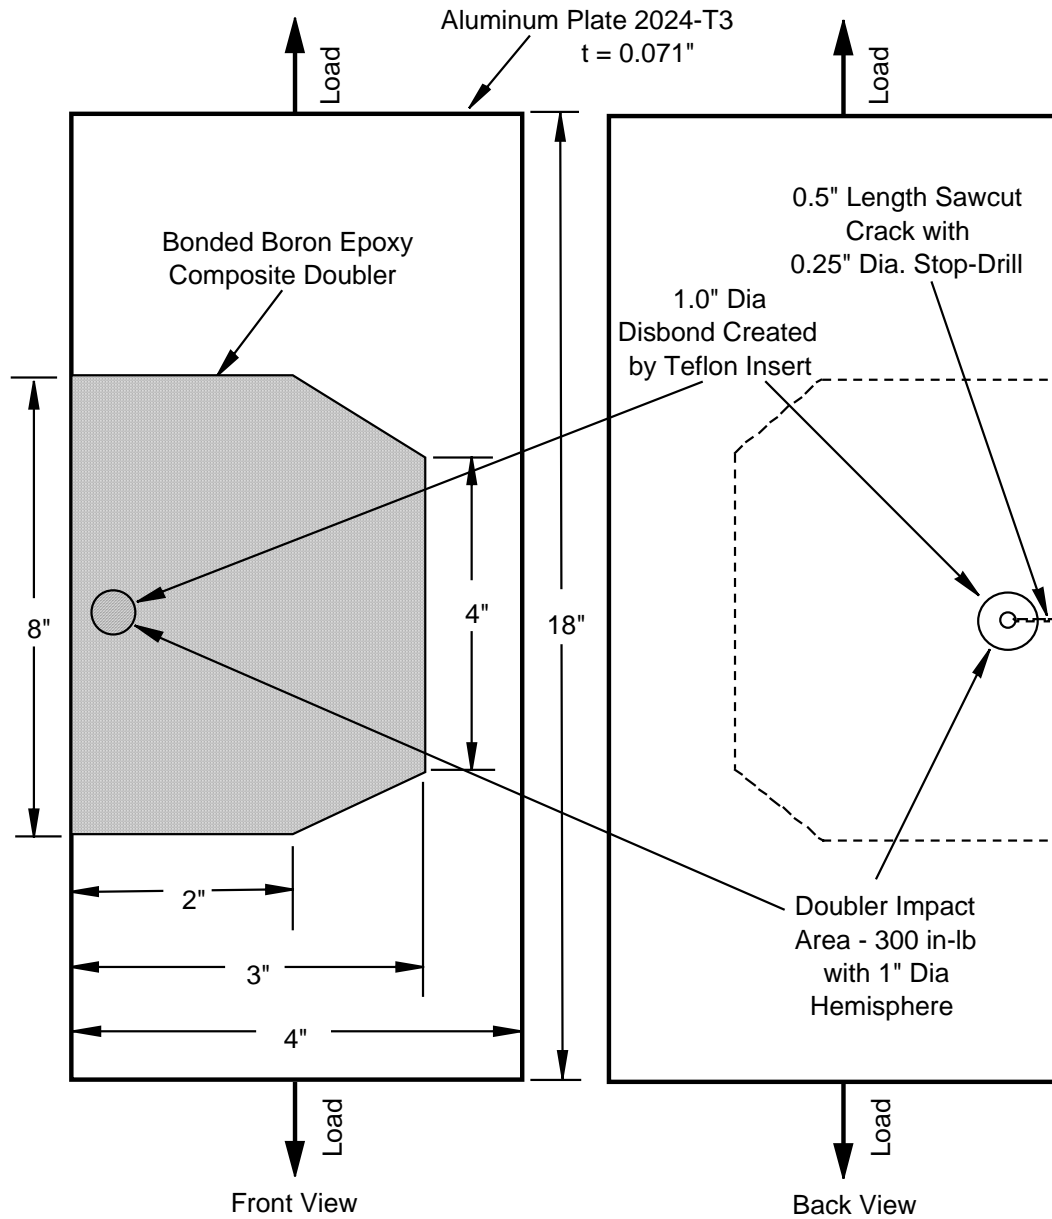
Figure 14: Composite Tension Test Coupon - Configuration BE-8

8. BE-8: Stop-drilled, 0.5" sawcut edge crack in the aluminum plate with collocated 300 in-lb impact damage from a 1" diameter hemispherical tip; collocated 1" diameter disbond; 160°F hot-wet conditioning (Figure 14).

1. 13 Ply Boron/Epoxy doubler
2. $[0, +45, -45, 90]_3$ lay-up (fiber orientation to the load) plus a 0° cover ply on top; longest ply on bottom
3. 30:1 taper ratio drop off
4. Stiffness Ratio, $(Et)_{BE} = 1.2 (Et)_{Al}$
5. Crack (stop-drilled) with 1.0" Dia co-located impact damage centered over stop-drill hole; 160°F hot, wet conditioned
6. 1.0" Dia disbond co-located over fatigue crack and impact damage

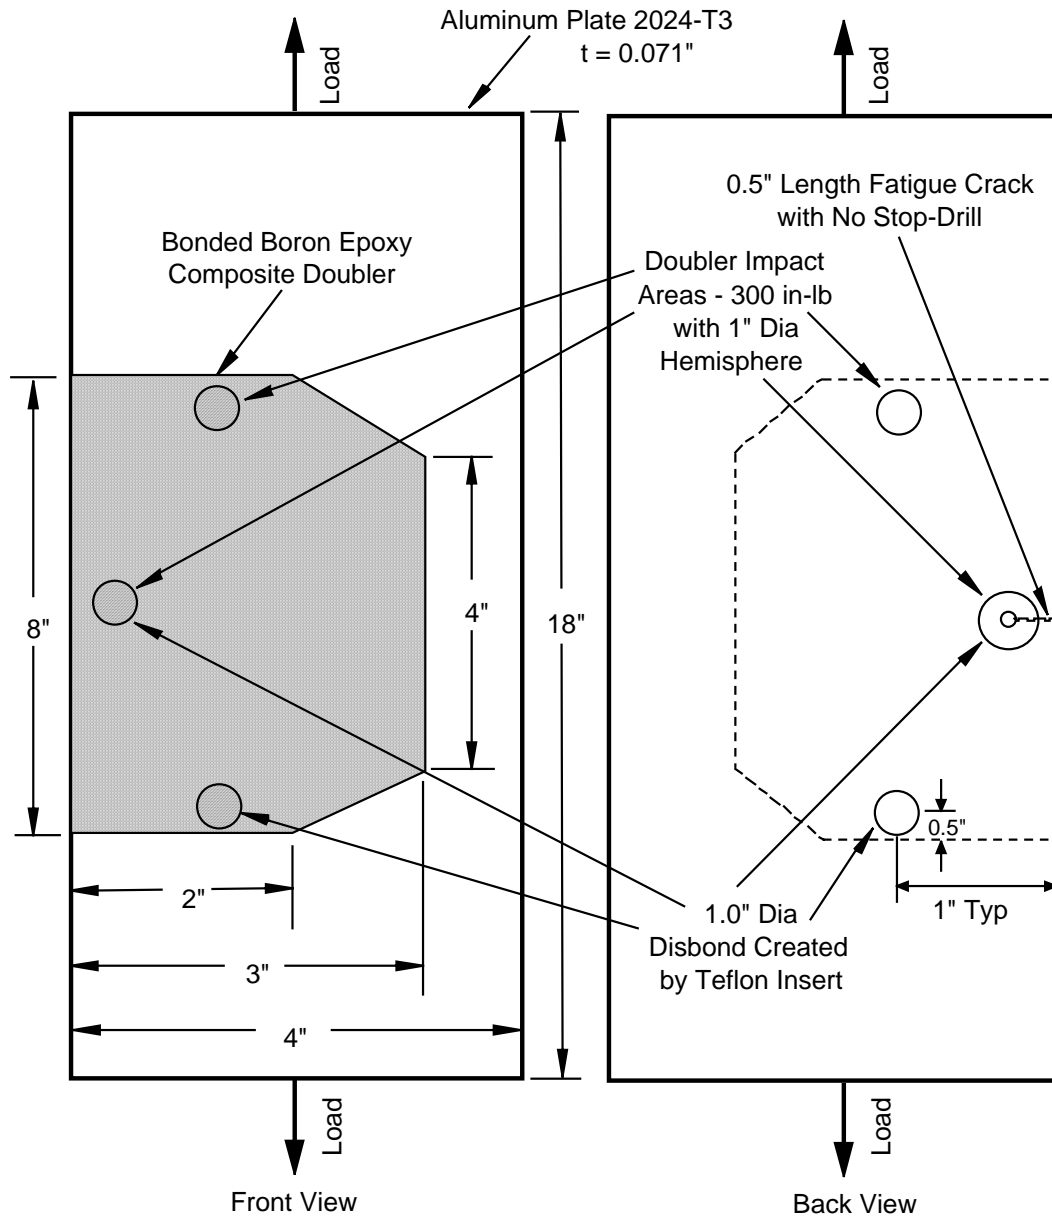
Figure 15: Composite Tension Test Coupon - Configuration BE-9

damage along doubler edge; collocated 1” diameter disbands at both impact locations; 160°F hot-wet conditioning (Figure 15).

BE-9	6 (Lock16 - Lock21)	15, 24	unabated 0.5'' fatigue edge crack with collocated impact/disbond damage on doubler; impact/disbond damage on edge of doubler; 160°F hot, wet conditioned; tested at room temperature

1. 13 Ply Boron/Epoxy doubler
2. $[0, +45, -45, 90]_3$ lay-up (fiber orientation to the load) plus a 0° cover ply on top; longest ply on bottom
3. 30:1 taper ratio drop off
4. Stiffness Ratio, $(Et)_{BE} = 1.2 (Et)_{Al}$
5. Crack (stop-drilled) with 1.0" Dia co-located impact damage centered over stop-drill hole; 160°F hot, wet conditioned
6. 1.0" Dia disbond co-located over fatigue crack; disbond and impact damage in load transfer regions (edges of bondline)

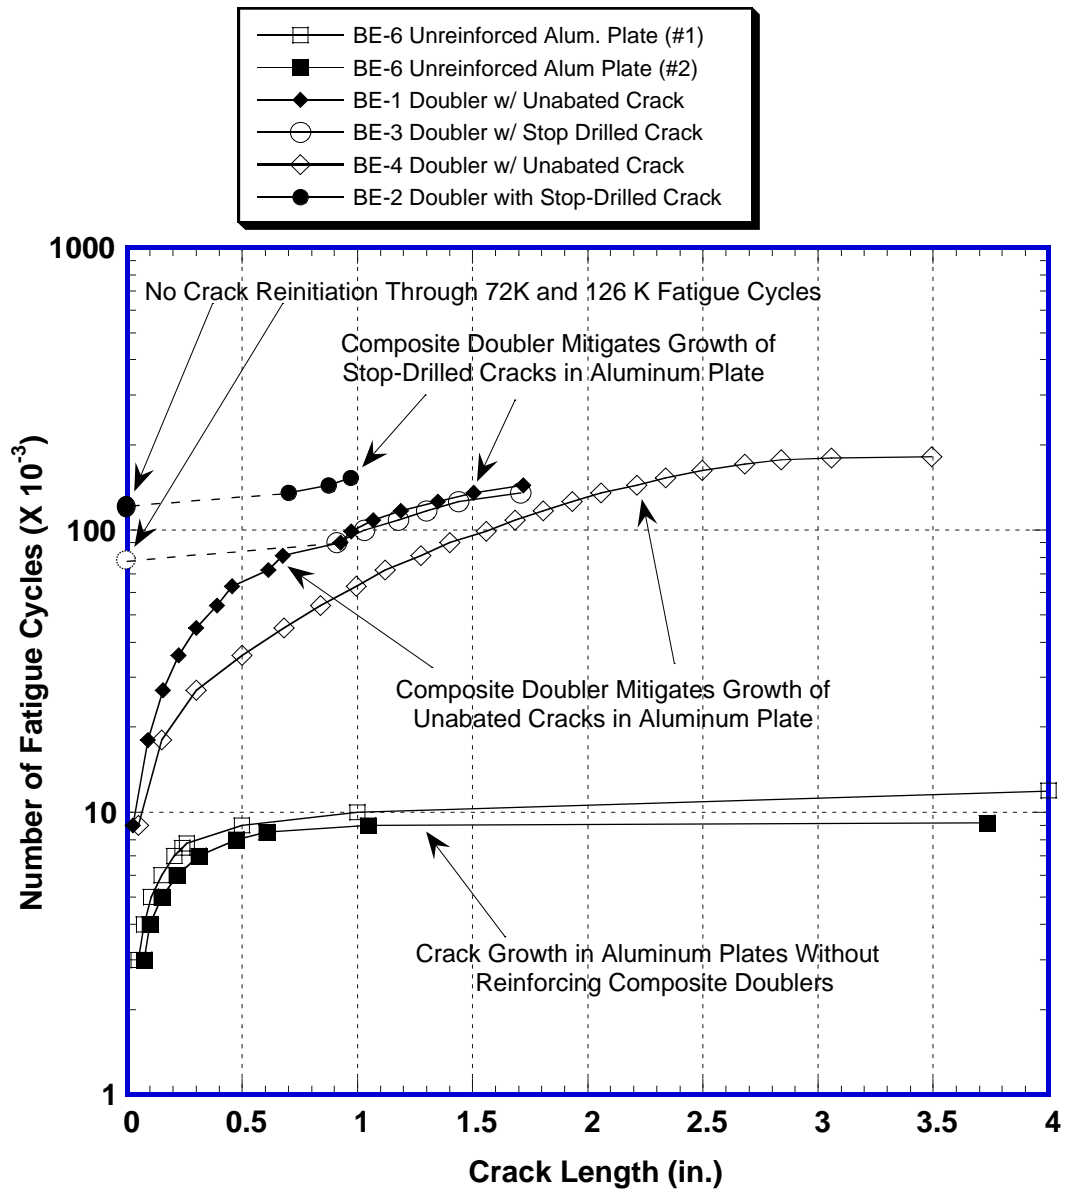
Figure 25: Fatigue Crack Growth in 2024-T3 Plates With and Without Reinforcing Composite Doublers
(Configurations BE-1 through BE-6; Specimens Lock1 through Lock7)

The results from the fatigue tests on specimens Lock 1 - Lock 21 (configurations BE-1 through BE-9) are summarized in Table 3 and shown graphically in Figures 25 and 26. The results have been broken down according to the specimen's flaw scenario and are provided in sections 3.1.1 to 3.1.6 below.

- a. Disbond and Crack Flaws - Note the delay in crack reinitiation until 72,000 and 126,000 cycles in the Figure 25 BE-2 and BE-3 curves. Because of this initial crack growth arrest, specimens Lock2 (BE-2) and Lock3 (BE-3) experienced total crack growths of less than 1.75" up through 144 K fatigue cycles (four design lifetimes of the L-1011 aircraft).

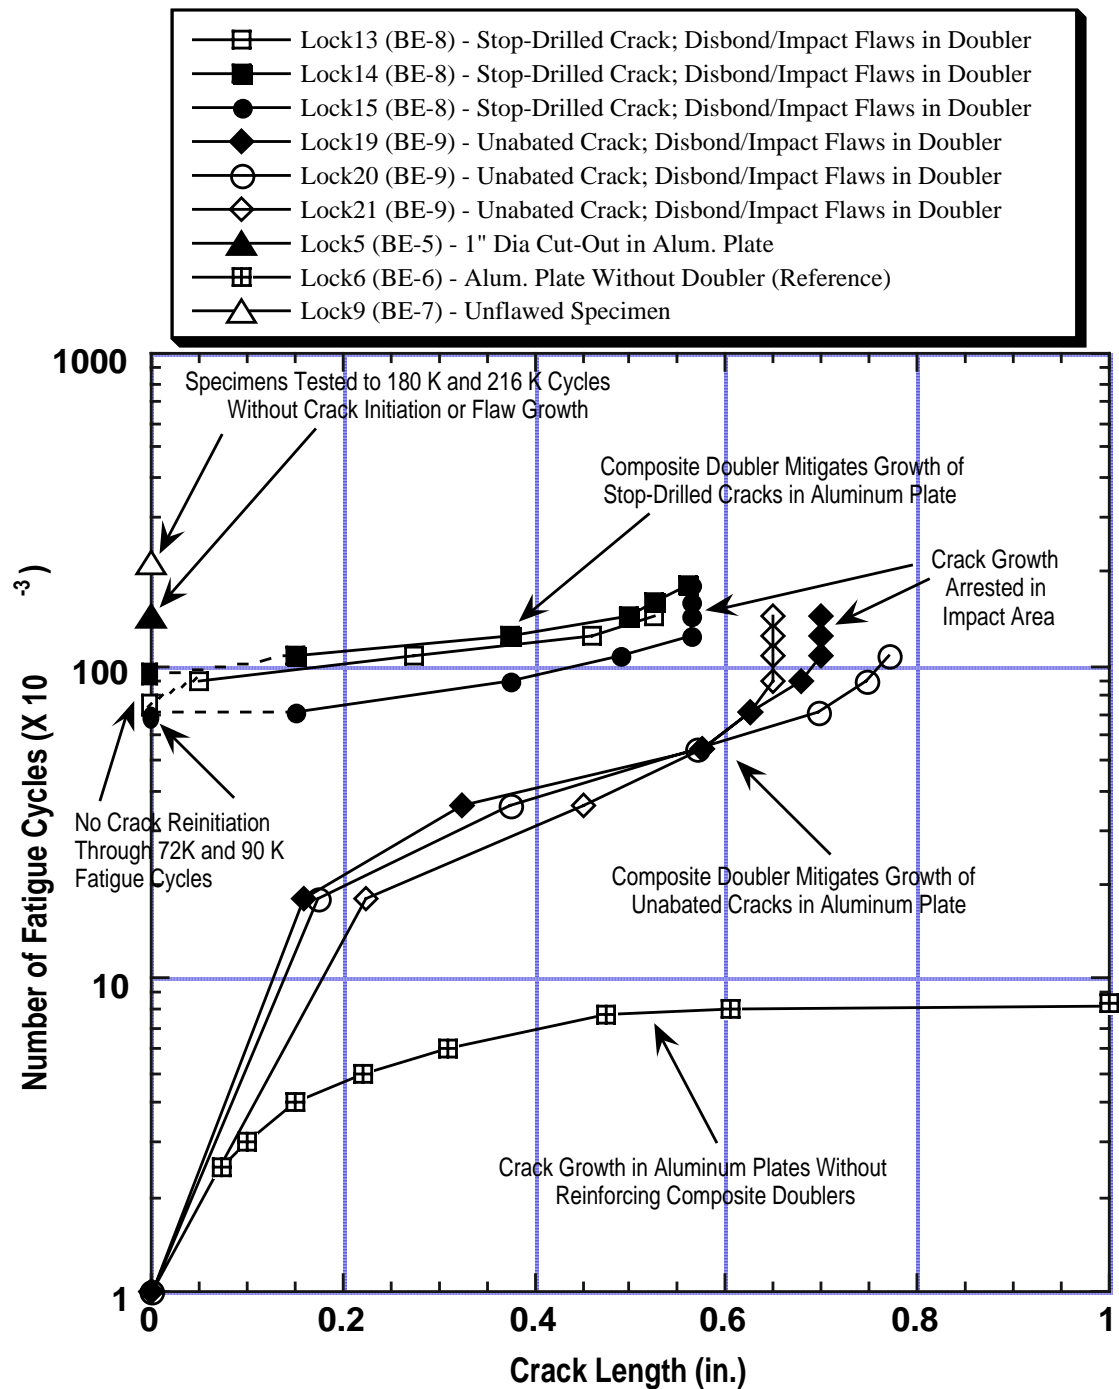
Figure 26: Fatigue Crack Growth in 2024-T3 Plates With and Without Reinforcing Composite Doublers
(Configurations BE-6 through BE-9; Spec. Lock6, Lock9, Lock10–12, Lock 16–18)

- b. Disbonds and Cracks with Impact Damage and Hot, Wet Conditioning - Figure 26 shows the fatigue crack growth for the unabated crack specimens in the BE-8 configuration. Note the delay in crack reinitiation until 72,000, 90,000, and 72,000 cycles, respectively in the Lock13, Lock14 and Lock15 specimens. In the BE-8 configuration, the disbonds noted above were accompanied by collocated impact damage directly over the crack (see Fig. 14). Prior to testing, the specimens were also subjected to hot, wet conditioning until a 10% (by weight) water absorption was achieved. Specimens Lock13, Lock14 and Lock15 experienced total crack growths of less than 0.060" up through 144,000 fatigue cycles. Note that specimens Lock14 and Lock15 were fatigued beyond the four lifetime test goal to 180,000 cycles (five L-1011 lifetimes). Little or no additional crack growth was observed.

collocated impact damage directly over the crack and along the edge of the doubler (see Fig. 15). Prior to testing, the specimens were also subjected to hot, wet conditioning until a 10% (by weight) water absorption was achieved. The impact phenomenon discussed above was also present in configuration BE-9; crack growth was arrested in the impact area. Specimens Lock19 and Lock21 experienced total crack growths of 0.70" or less after 144,000 fatigue cycles. The plots of Lock19 and Lock21 in Fig. 26 show that all of the crack growth occurred during the first 90,000 fatigue cycles after which time the crack growth was halted in the impact area.

After three fatigue lifetimes, the Lock20 specimen experienced crack growth of less than 0.80". Thus, an allowable crack length of 1.0" would still not be present after 108,000, post-installation "flight" cycles. Unfortunately, it appears that this specimen had a small notch (manufacturing or handling defect) in the edge of the aluminum skin. The notch may have acted as an initiator for a crack which formed just outside the upper boundary of the composite doubler footprint. This crack, without the benefit of the doubler reinforcement, grew across the aluminum plate and caused a failure of the test specimen outside of the doubler. As a result, no doubler performance data could be obtained beyond 108,000 fatigue cycles.

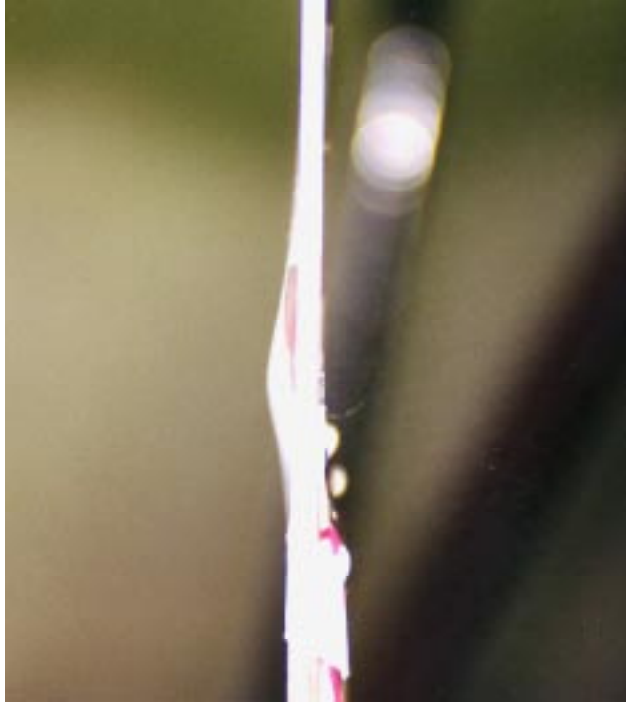
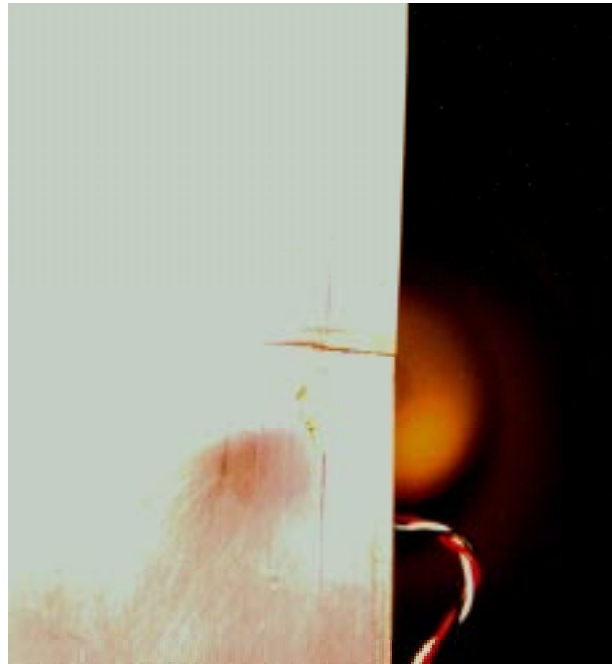
Following the composite doubler installation and prior to environmental conditioning (see section 2.3.4), impact damage was imparted to Specimen Configurations BE-8 and BE-9 (specimens Lock10-Lock21). The locations for impact damage were selected to induce the most adverse effect on crack growth mitigation and/or the ability of the doubler to transfer load. Figures 14 and 15 and drawing AANC-1 (see Appendix A) provide the design, fabrication and inspection details. The impact was performed with a 1 inch diameter steel hemisphere tip. A guide tube, lined with Teflon film or equivalent, was used to direct the path of the impact mass. The specimens were fully supported by plates on the front and back side. The plates had appropriate window cut-outs to apply the impact damage.

Figure 27: Impact Damage on Composite Coupons

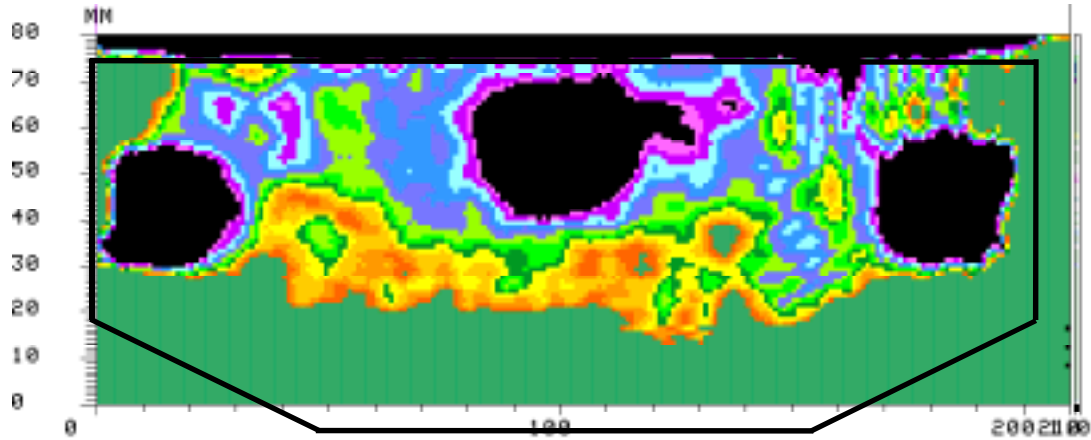
Specimen Before Fatigue Testing

Figure 30: Fatigue Specimen Lock3 (Configuration BE-3) Flaw Profile Before and After 144,000 Fatigue Cycles

Black Areas Indicate
Disbond or Delamination Flaws

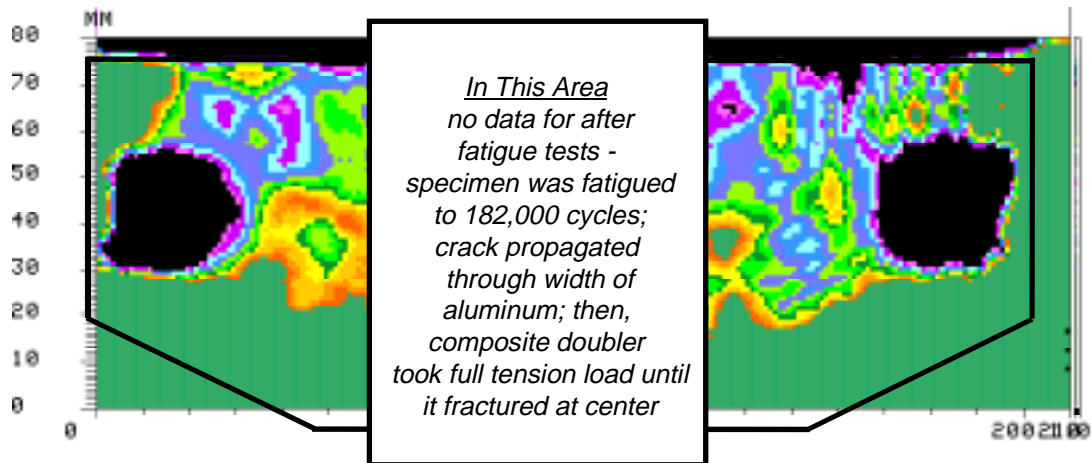
- 2) Specimen Lock4 (Config. BE-4; ref. flaw drawing Fig. 10) - Figure 31 shows that the disbond flaws - located in the critical load transfer region at the doubler's edge - did not grow or change shape during the fatigue tests. This specimen was fatigued beyond the limits of the test goals in order to determine a cycles-to-failure number for this configuration. The crack propagated through the specimen after 182,000 cycles (in excess of five lifetimes). Since the specimen was failed, it was not possible to obtain NDI data in the area of failure as shown in Fig. 31.

**Figure 31: Fatigue Specimen Lock4 (Configuration BE-4) Flaw Profile
Before and After 182,000 Fatigue Cycles**

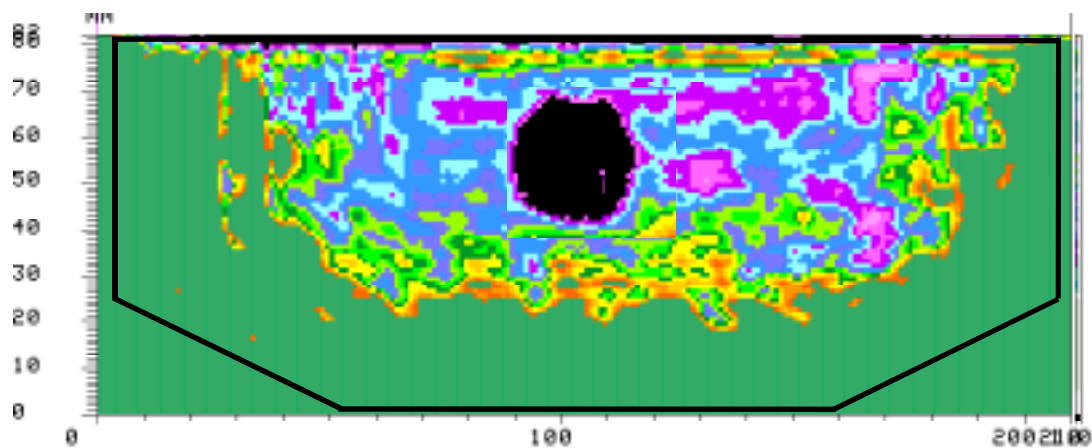
- 3) Specimen Lock 5 (Config. BE-5; ref. flaw drawing Fig. 11) - The 1" diameter cut-out in the aluminum plate is visible in Figure 32. There are no other flaws in the installation. No disbonds initiated during 180,000 fatigue cycles.

Figure 32: Fatigue Specimen Lock5 (Configuration BE-5) Flaw Profile Before and After 180,000 Fatigue Cycles; No Flaw Growth After Five L-1011 Fatigue Lifetimes

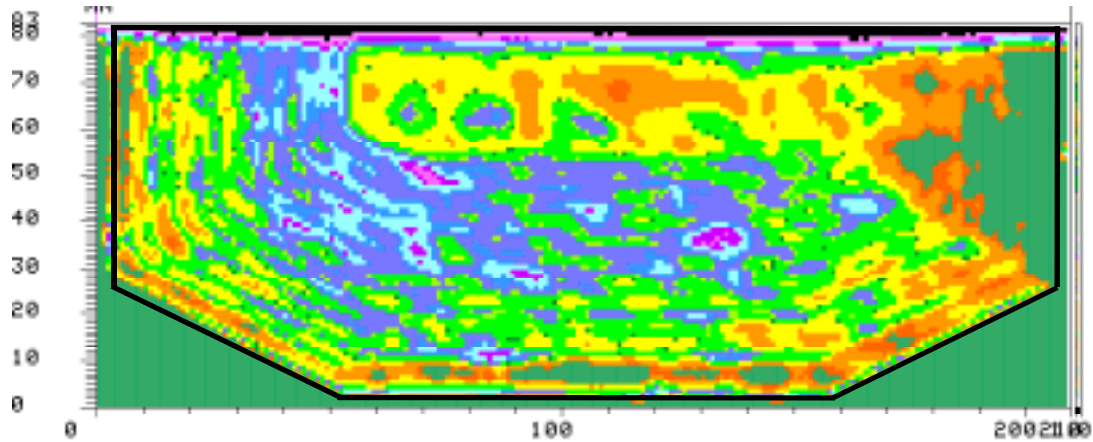
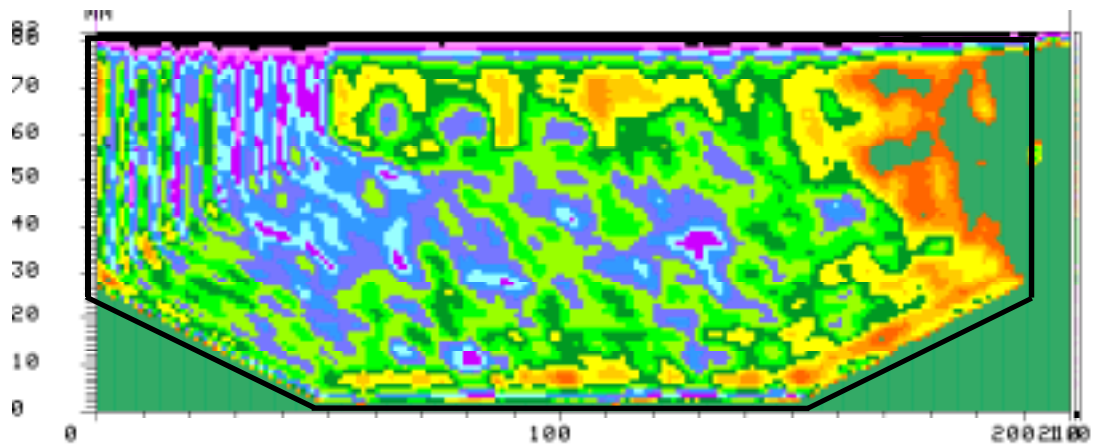
- 4) Specimen Lock9 (Config. BE-7; ref. flaw drawing Fig. 13) - This configuration represents the optimum installation and Figure 33 shows that the test specimens did not have any flaws. Further, post-test inspections revealed that no disbonds or delaminations developed during 216,000 fatigue cycles (six L-1011 lifetimes).

**Figure 33: Fatigue Specimen Lock9 (Configuration BE-7) Flaw Profile
Before and After 216,000 Fatigue Cycles;
No Flaw Growth After Six L-1011 Fatigue Lifetimes**

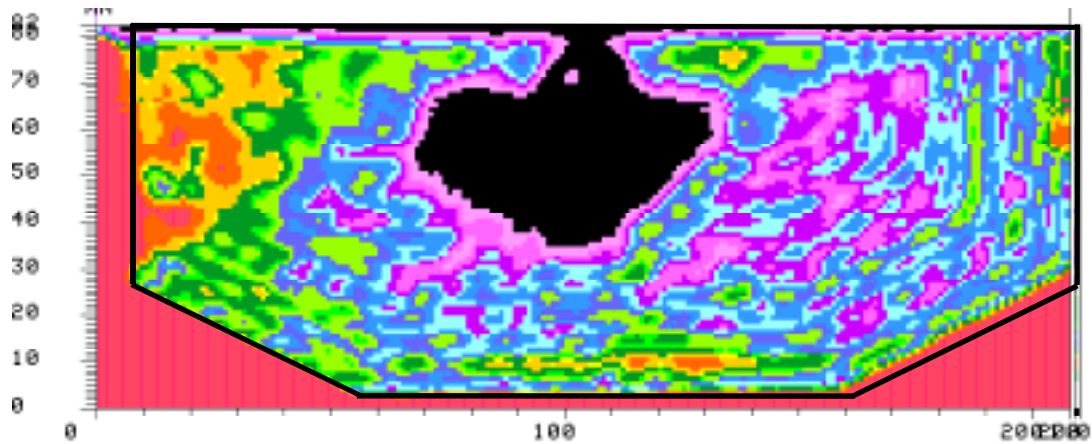
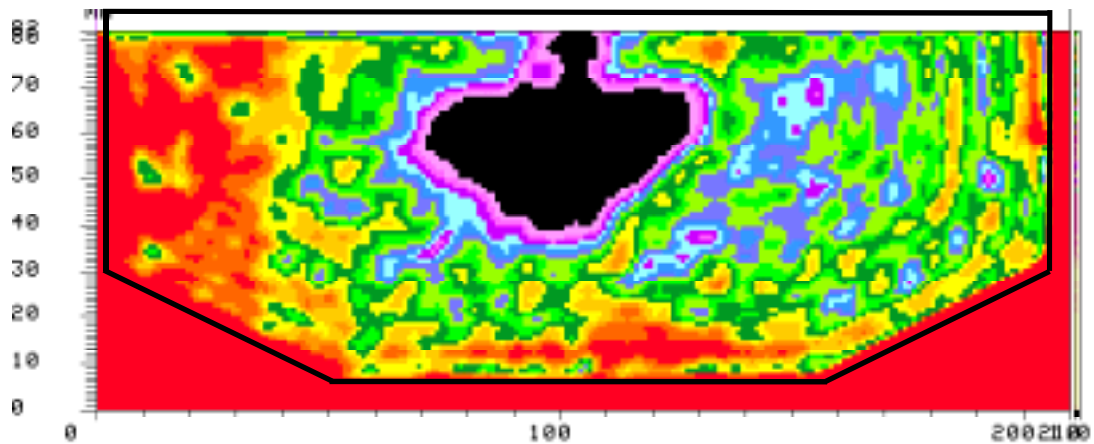
- 5) Specimens Lock13 and Lock14 (Config. BE-8; ref. flaw drawing Fig. 14) - Figures 34 and 35 contain the before-and-after fatigue test comparisons of NDI results. The ultrasonic scans show: 1) the engineered disbond and impact damage in the original test specimens and, 2) no change in the specimens' flaw profile after 144,000 and 180,000 fatigue cycles.

**Figure 34: Fatigue Specimen Lock13 (Configuration BE-8) Flaw Profile
Before and After 144,000 Fatigue Cycles;
No Change in Flaw Profile After Four L-1011 Fatigue Lifetimes**

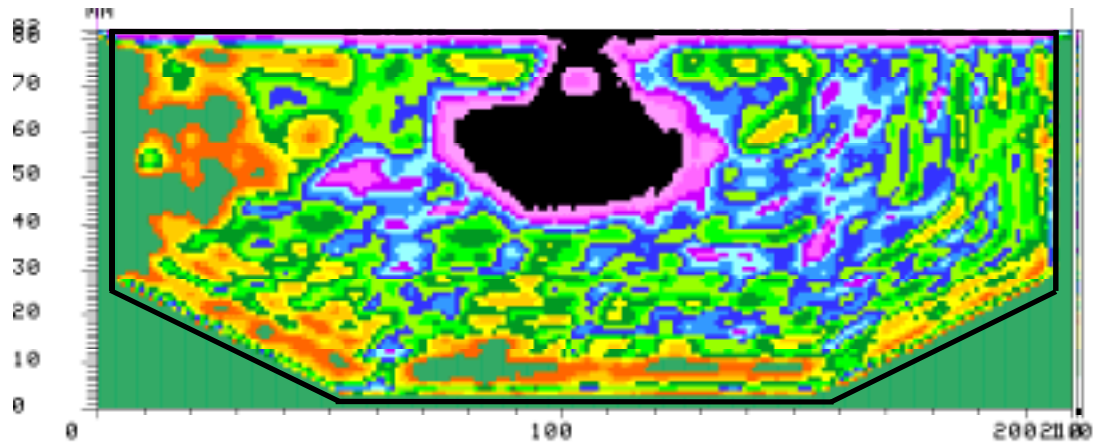
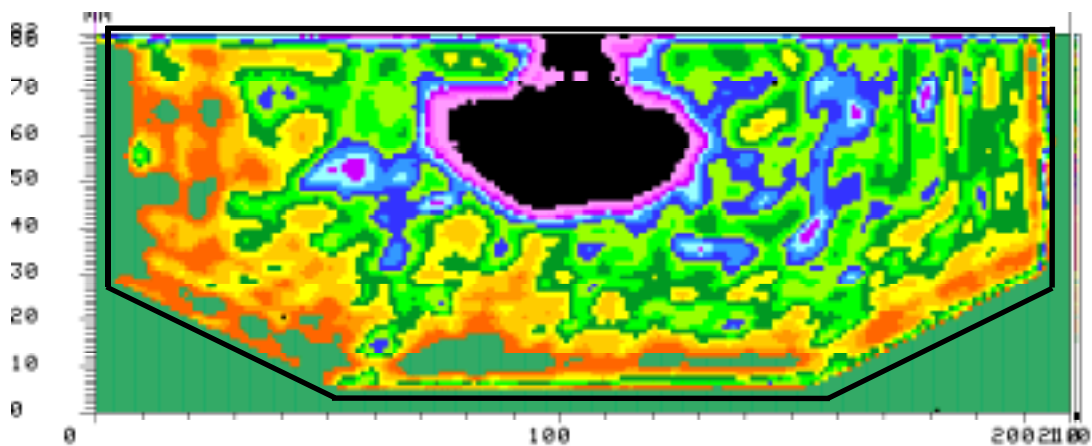
**Figure 35: Fatigue Specimen Lock14 (Configuration BE-8) Flaw Profile
Before and After 180,000 Fatigue Cycles;
No Change in Flaw Profile After Five L-1011 Fatigue Lifetimes**

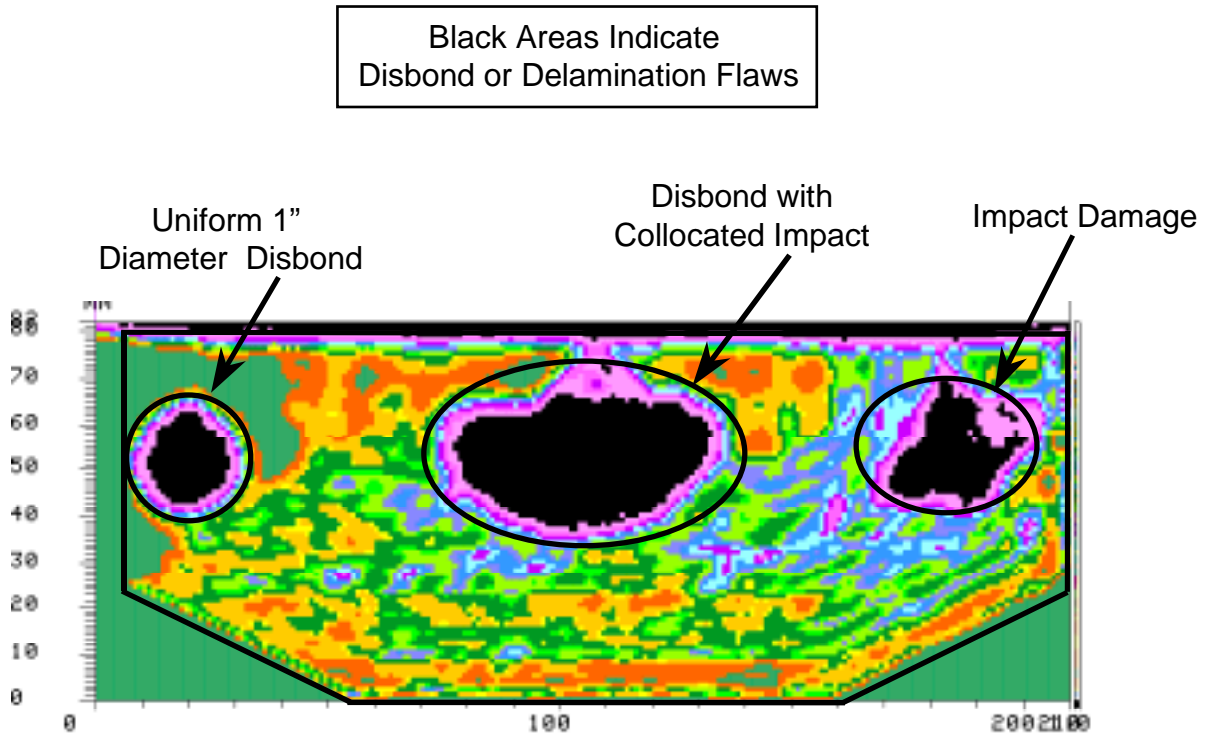
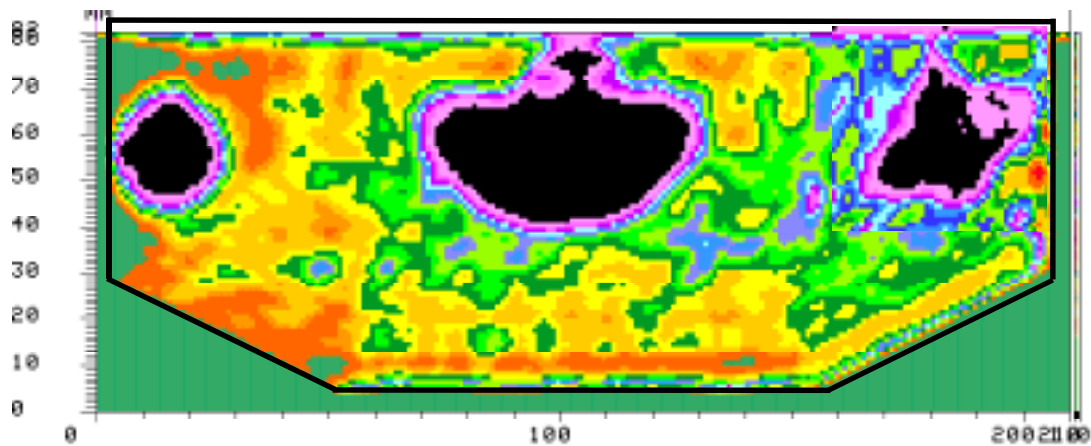
- 6) Specimens Lock19, Lock20, and Lock21 (Config. BE-9; ref. flaw drawing Fig. 15) - Figures 36 - 38 contain the before-and-after fatigue test comparisons of NDI results. The ultrasonic scans show: 1) the three disbond and impact damage areas in the original test specimens and, 2) no change in the specimens' flaw profile after 108,000 and 144,000 fatigue cycles.

Figure 36: Fatigue Specimen Lock19 (Configuration BE-9) Flaw Profile Before and After 144,000 Fatigue Cycles; No Change in Flaw Profile After Four L-1011 Fatigue Lifetimes

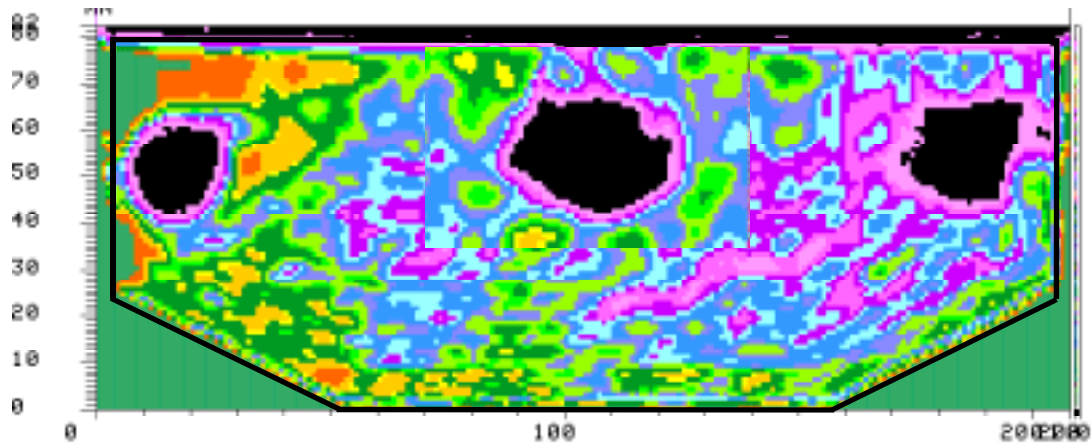
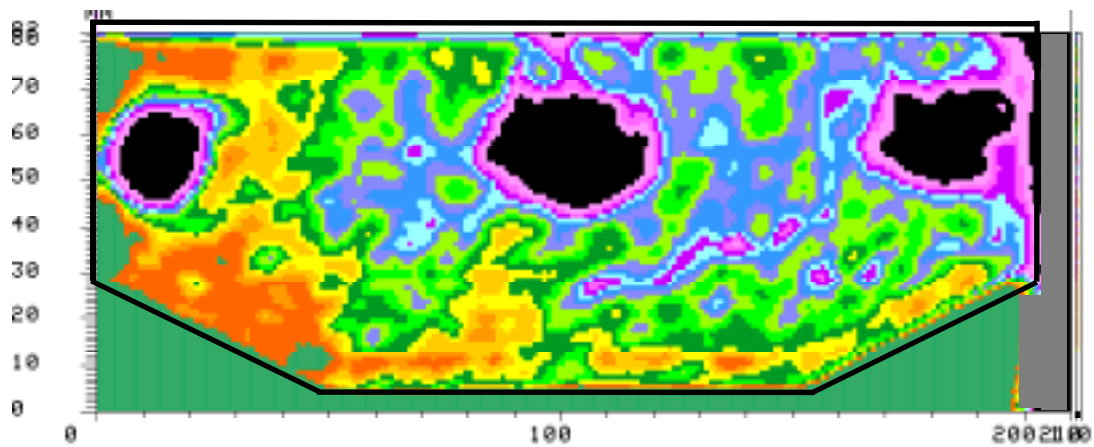
**Figure 37: Fatigue Specimen Lock20 (Configuration BE-9) Flaw Profile
Before and After 108,000 Fatigue Cycles;
No Change in Flaw Profile After Three L-1011 Fatigue Lifetimes**

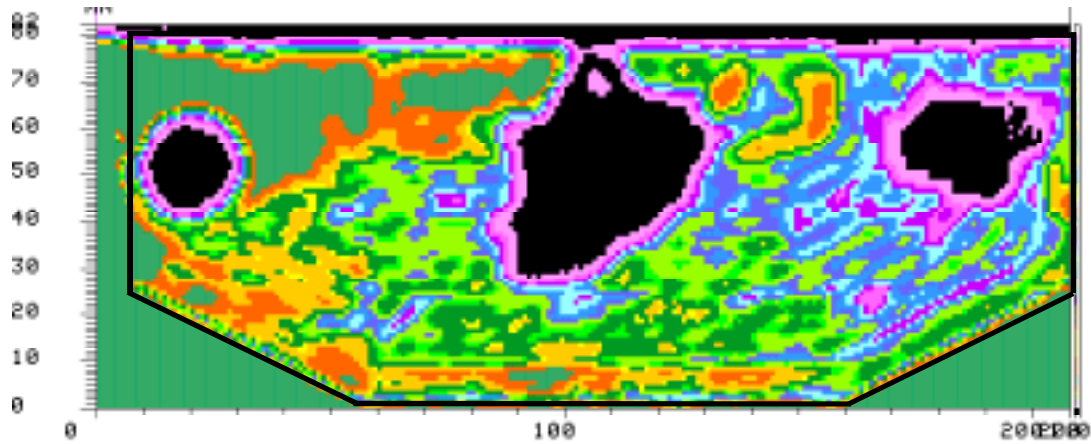
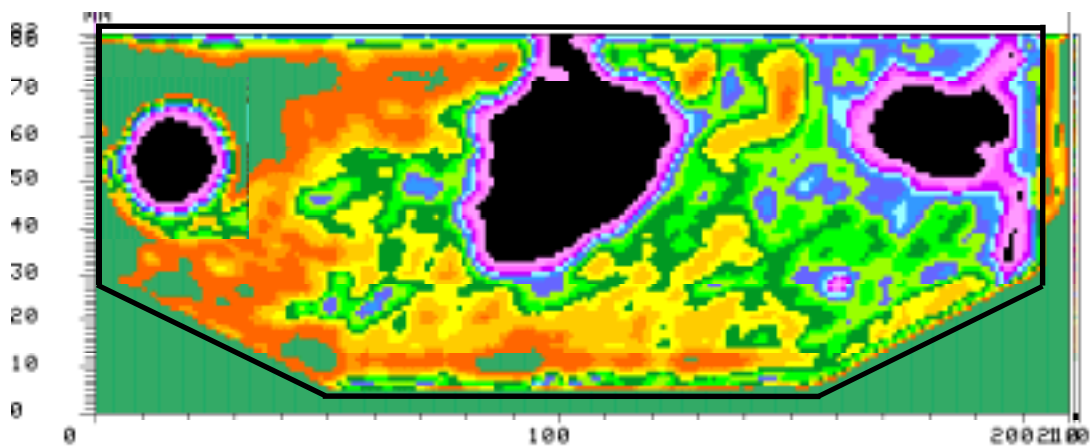
**Figure 38: Fatigue Specimen Lock21 (Configuration BE-9) Flaw Profile
Before and After 144,000 Fatigue Cycles;
No Change in Flaw Profile After Four L-1011 Fatigue Lifetimes**

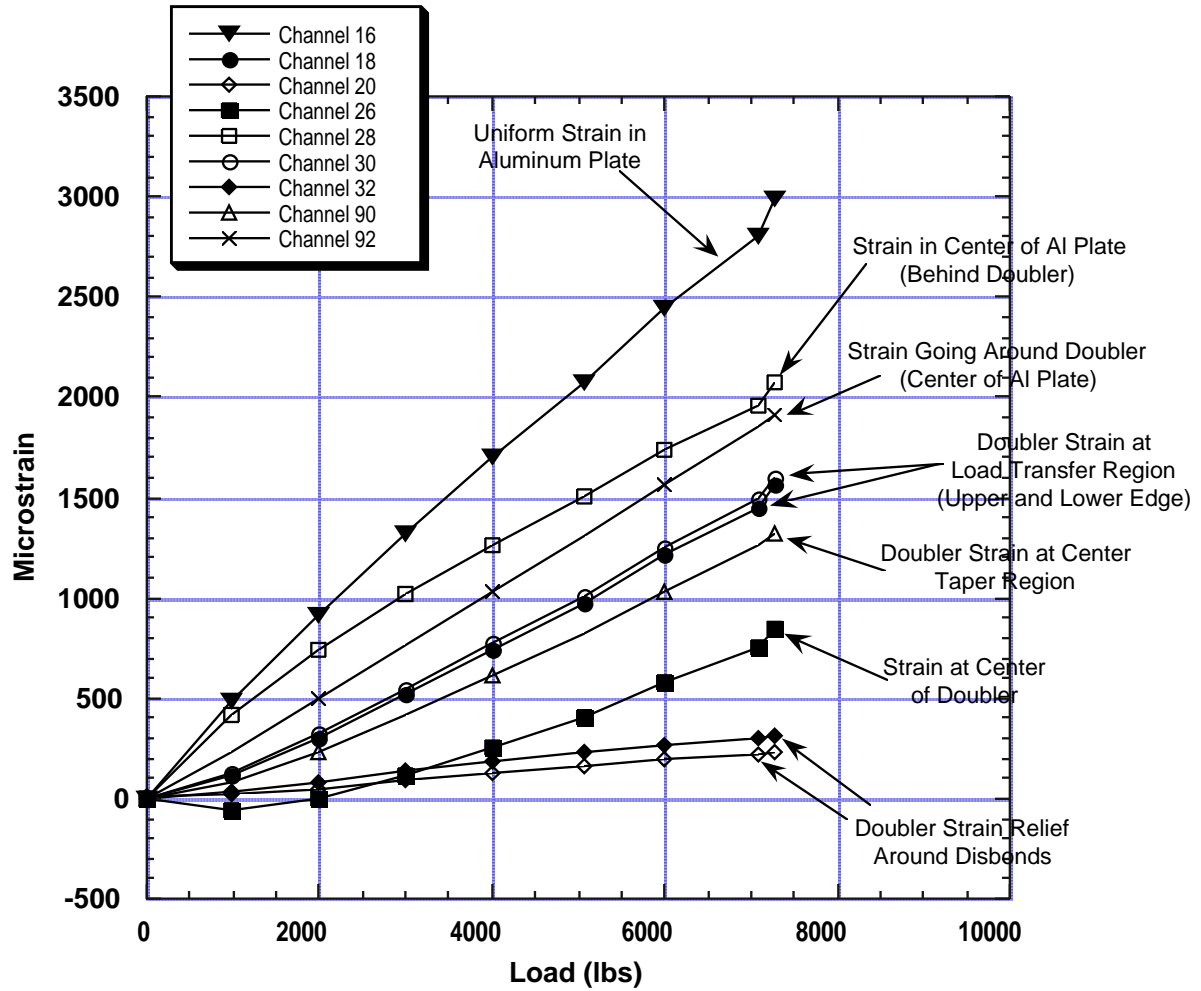
- b. Configuration BE-2 (Specimen Lock 2; ref. Fig. 17 for gage locations) - axial strains are shown in Fig. 41; lateral strains are shown in Fig. 42. The load transfer is similar at the upper and lower taper regions (compare Ch. 18 and Ch. 30). The strain relief created by disbonds is evidenced by the low strains in Ch. 20 and 32. The large strains in gages immediately adjacent to the disbond (Ch. 18 and Ch. 30) demonstrate that the disbond effects are very localized. The doubler does not create excessive strain risers in the unreinforced aluminum immediately adjacent to the doubler (Ch. 92).

Figure 41: Axial Strain Field in Aluminum and Composite for Configuration BE-2 Specimens (ref. strain gage locations shown in Figure 17)

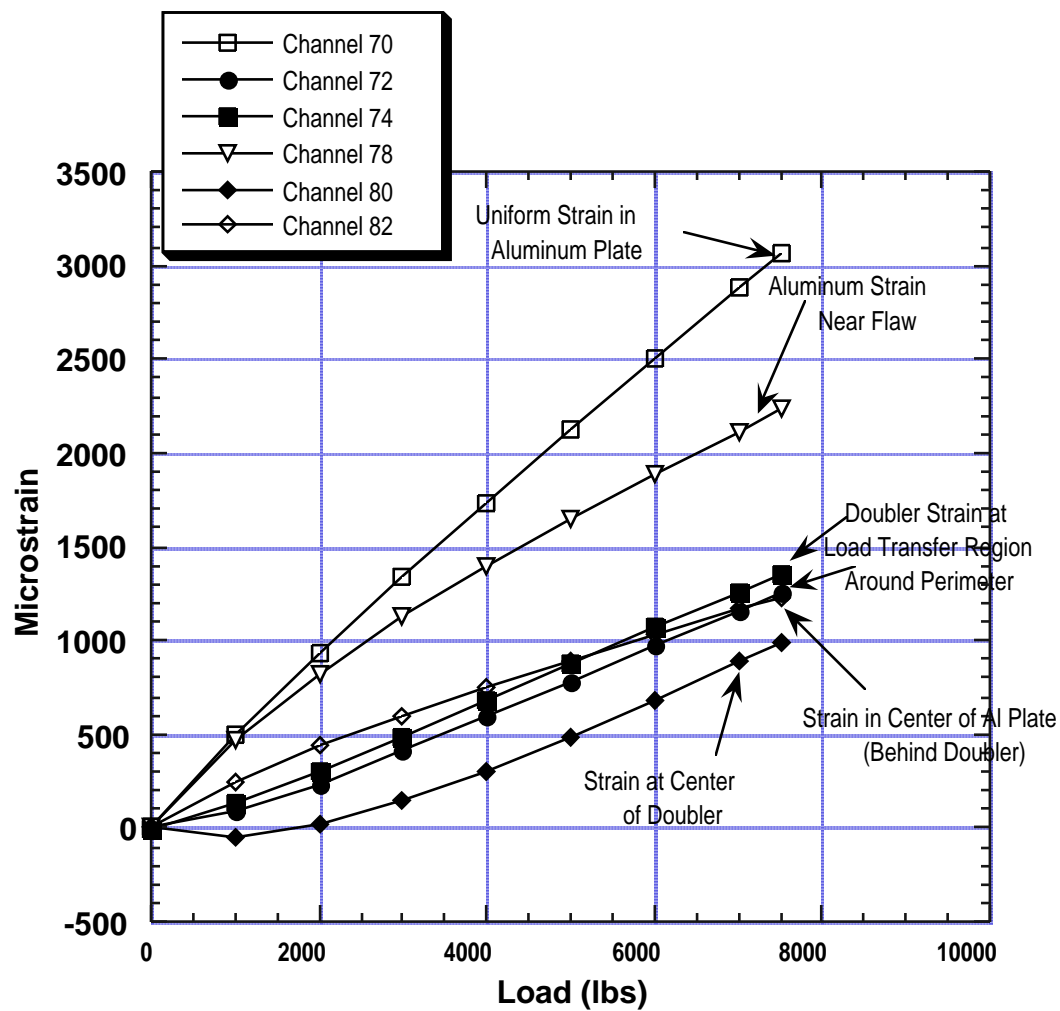
- e. Configuration BE-5 (Specimen Lock5; ref. Fig. 20 for gage locations) - axial strains are shown in Fig. 47; lateral strains are shown in Fig. 48. The strain fields and insights are similar to the BE-1 and BE-2 results. Note that strain risers around unreinforced holes are generally on the order of three times the uniform strain field away from the hole. Channel 78 shows that the strains at the aluminum cut-out are reduced substantially by the doubler. Rather than exhibiting the normal strain intensification (i.e. $6,000 \mu\epsilon = 2 \times 3,000 \mu\epsilon$ in uniform field), the strains are reduced below those of the gage outside the doubler area ($2,250 \mu\epsilon$).

Figure 47: Axial Strain Field in Aluminum and Composite for Configuration BE-5 Specimens (ref. strain gage locations shown in Figure 20)

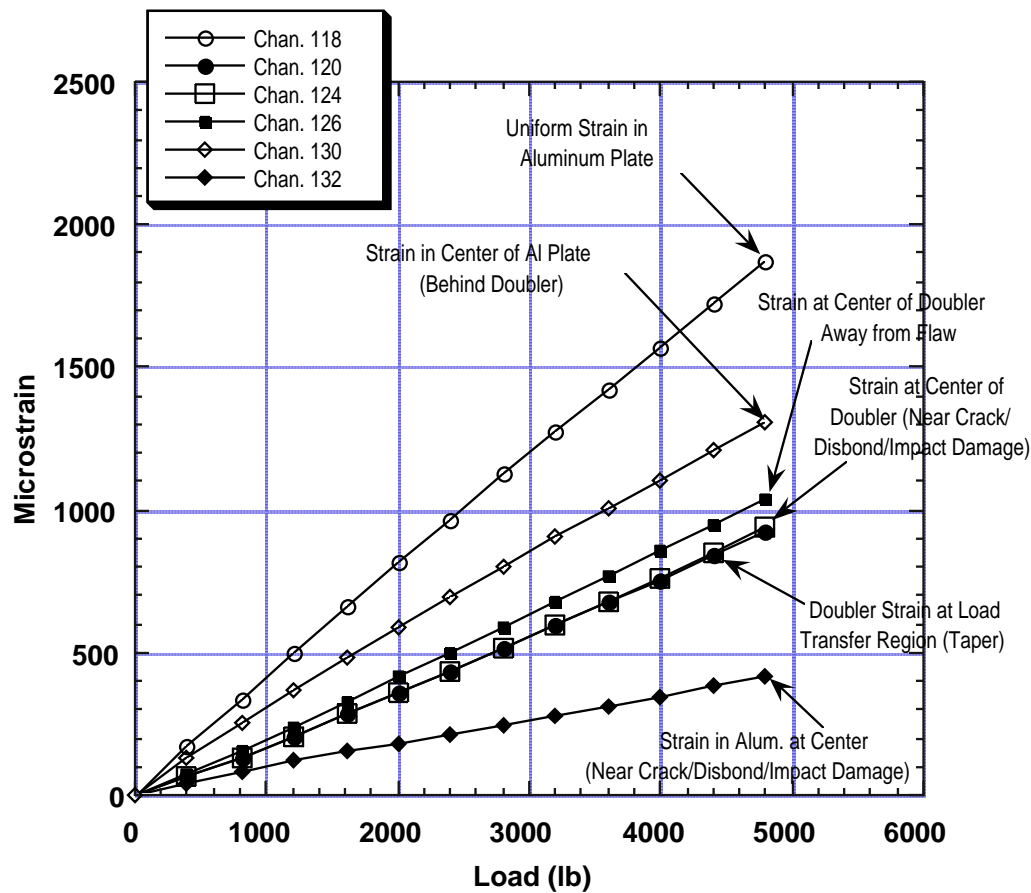
- g. Configuration BE-8 (Specimen Lock14; ref. Fig. 23 for gage locations) - axial strains are shown in Fig. 50. The strain fields and insights are similar to the BE-1 through BE-5 results. The addition of impact damage to the center disbond did not degrade the doubler's ability to absorb a significant portion of the total strain in this region. Figures 29 and 30 show the typical flaw induced in configuration BE-8 specimens. However, channel 124 in Fig. 50 still indicates a 50% load transfer in the flaw area.

Figure 50: Axial Strain Field in Aluminum and Composite for Configuration BE-8 Specimens (ref. strain gage locations shown in Figure 23)
